ASCSA Excavations
in Ancient Corinth
2020 Report

Excavations Northeast of the Theater

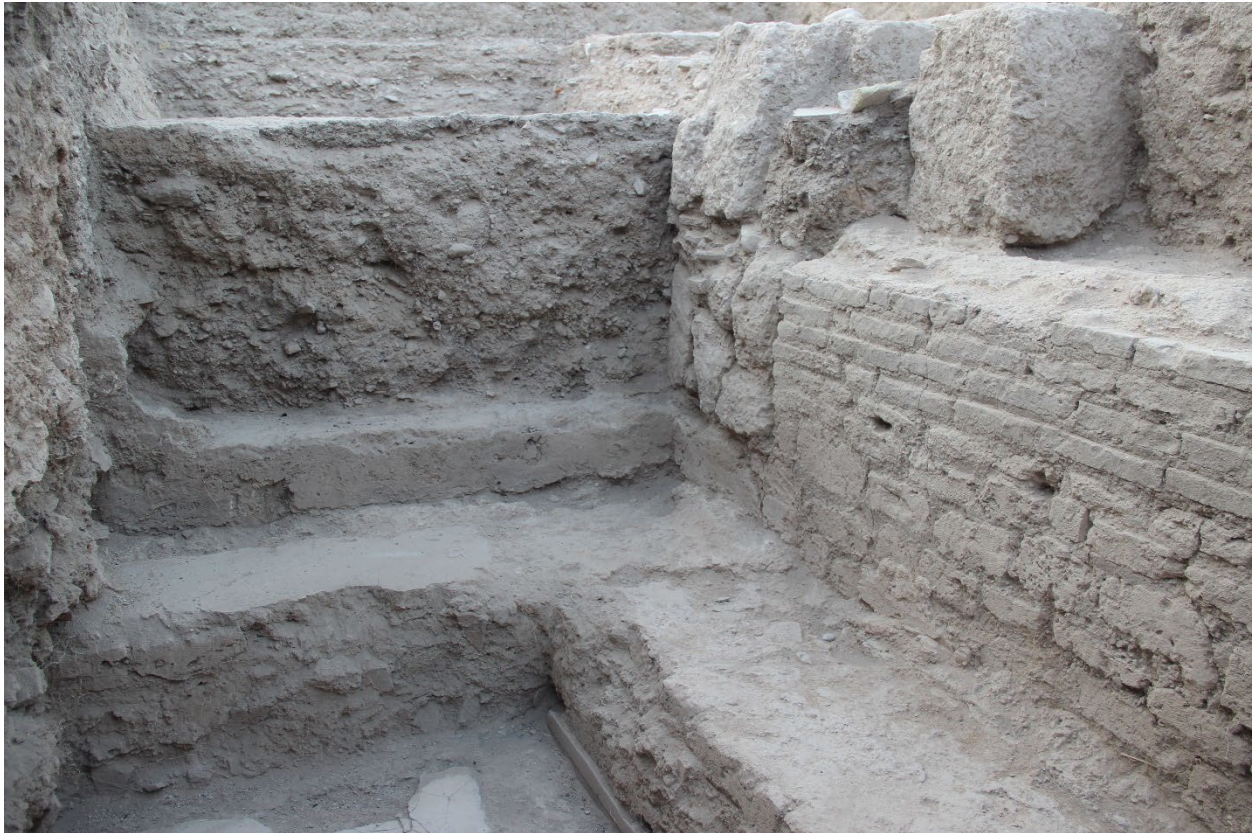
Figure 2. Southeast corner of the newly discovered Roman room with heavy walls, marble pavement, and a bench

Excavation revealed that the south wall of the Byzantine room was founded on the remains of a very substantial Roman wall (Figure 2). The lower part of this wall is faced with

semi-coursed poros blocks set in mortar, while the upper part is faced with bricks set in mortar. Remains of an iron clamp and holes for other clamps indicate that this wall was originally covered with revetment. At its east end, this wall meets a less well preserved north-south wall of similar construction. A bench (or podium?), about 0.37 high and 0.58 m wide, was revealed along the exposed faces of these two Roman walls. That this bench was originally covered with revetment is indicated by small fragments of thin white marble slabs adhering to the bottom of the front face of the bench. The floor of the room defined by the walls was found to be paved with large white marble floor slabs. The construction date of this well-appointed Roman room

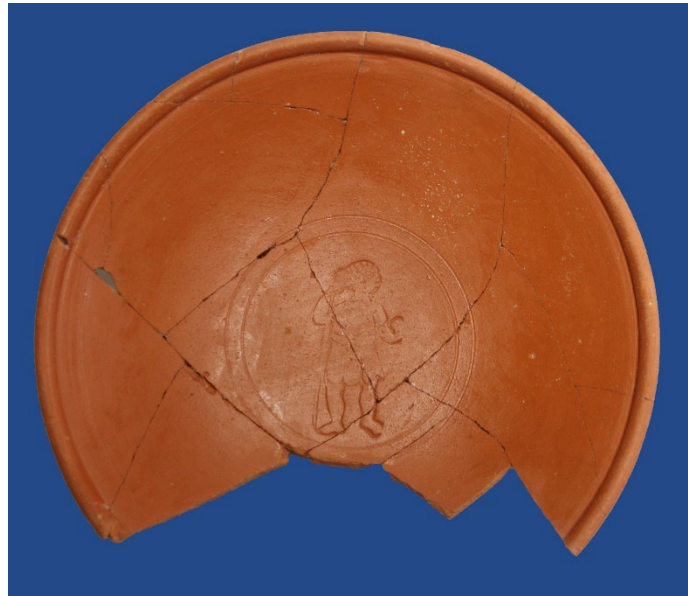
Figure 3. African Red Slip bowl with stamped decoration

has yet to be determined, but finds from the fill over the floor, which included a considerable quantity of building debris, indicates that it was probably destroyed in the 7th century (Figures 3-5). Given the fact that the exposed portion of this Roman room lies less than 30 m southeast of the remains of a large Roman building that has long been identified as a likely bathing complex (the Baths North of the Theater), it is tempting to conclude that the newly revealed room represents eastern extension of that building. Further excavation and prospection will, however, be needed to confirm if this is in fact the case.

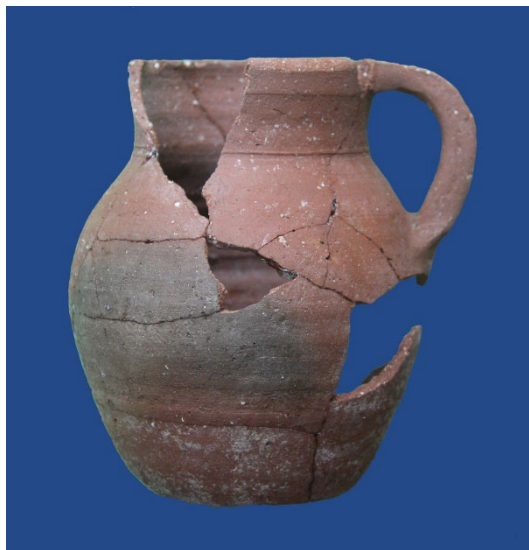
Figure 4. Small jug in cooking fabric

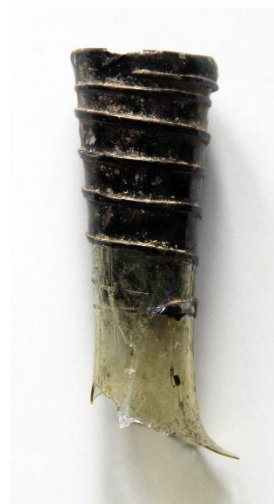
Figure 5. Glass bottle

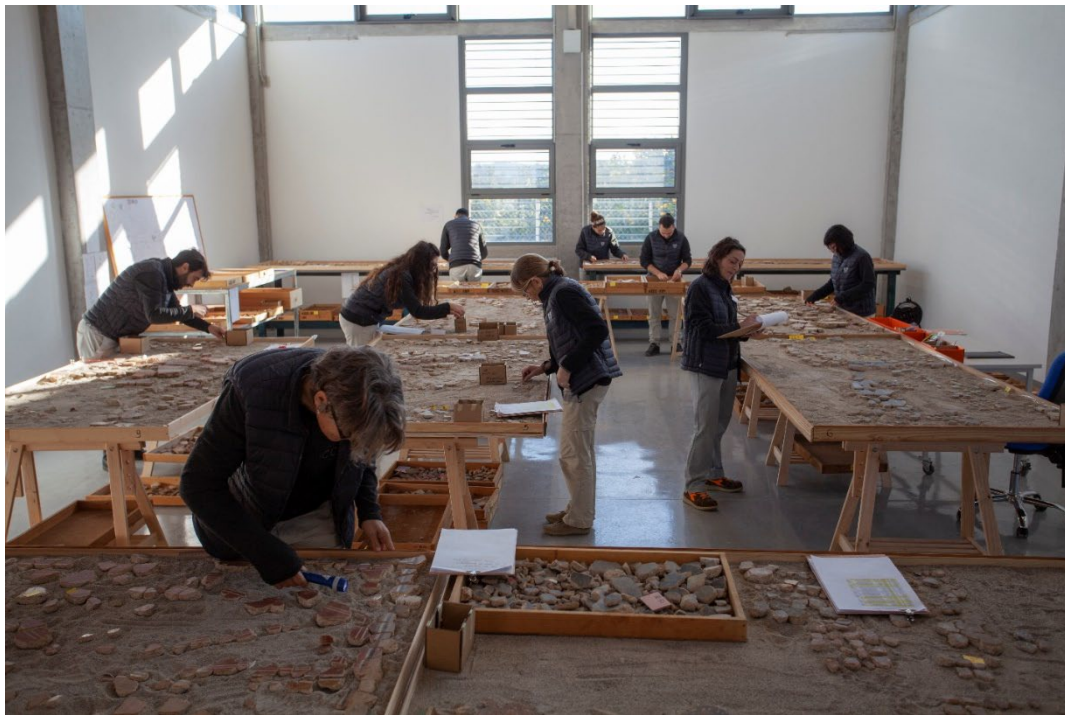
Figure 6. Conservation of wall-paintings from the area east of the Theater

Beginning in November of 2019, a team of conservators from the Centro di Conservazione Archeologica – Roma (directed by Roberto Nardi) has been at work cleaning and joining fragments of wall-paintings from the area to the east of the Theater, excavated in the 1980s under the direction of Charles K. Williams, II (Figure 6). Work was interrupted in March because of the COVID-19 outbreak, but it resumed in July and is expected to continue into 2021. The final goal of this project is to assemble and consolidate the extant fragments of wall-paintings into panels that will restore as much as possible of the original designs of the walls and allow the fragments to be safely displayed.
